Fiber Orientation in Fiber-Reinforced Plastics and How it Affects Automotive Applications

E. M. Rowbotham
Ford Motor Co., Ltd.

Automotive Engineering Congress
Detroit, Mich.
February 25 - March 1, 1974

740264

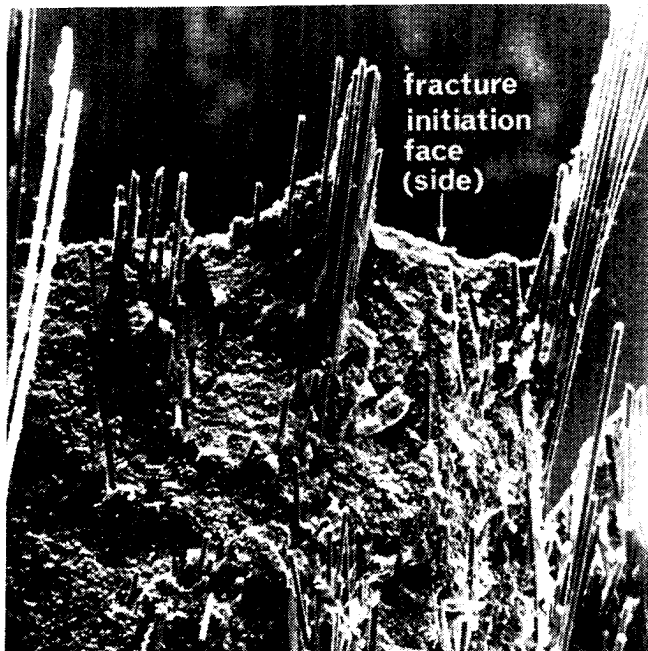
Fig. 4 - Fracture surface of high-strength specimen, stereoscan micrograph, X85 reduced 55% for reproduction

Fig. 3 is a stereoscan micrograph of the fracture surface of a low-strength specimen. It will be observed that fiber orientation lies predominantly perpendicular to the specimen's axis. A stereoscan micrograph of a high-strength specimen's fracture surface (Fig. 4) showed the fibers oriented parallel to the specimen's axis, while in Fig. 5, a medium-strength specimen depicts the fibers angularly disposed between the longitudinal and transverse axis of the specimen. Fibers so aligned will only partially contribute to the overall strength of the test piece.

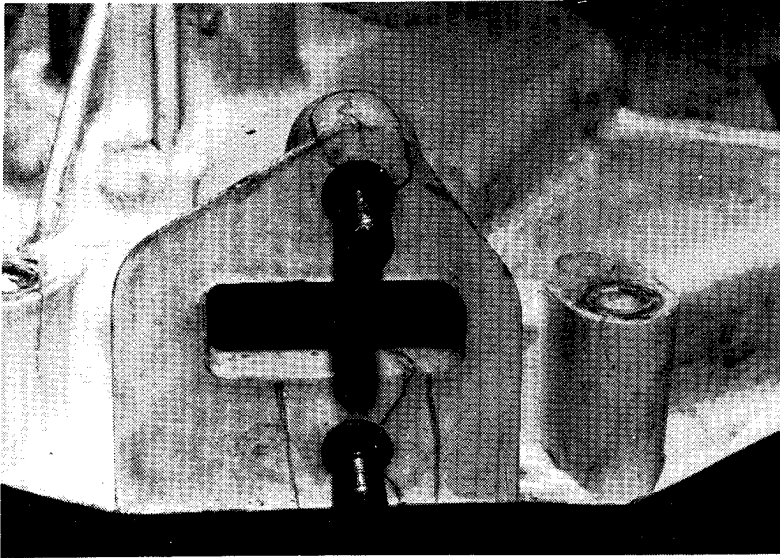
FUEL PUMP FLANGE - This flange was particularly vulnerable to cracking (Fig. 8). The geometry of this molding section with its retractable core and inserts created a characteristic flow in the material during molding. Etched sections (Fig. 9) showed how the material flow separated into two streams on either side of the retractable core, joining together again on either side of each of the two inserts to form a characteristic weld line. The glass fiber followed the flow, orienting itself parallel to the weld line. The glass fiber never bridged the weld line. Cracking occurred either at the resin weld line or parallel to it, following the fiber orientation on either side of the insert. Of the 36 moldings tested, only one did not fail in this manner.

Fig. 8 - Front timing cover fuel flange showing typical cracking

Redesign and change in the molding technique is currently being undertaken to obviate failure; for example, placing molding material, SMC or DMC, into this section of the mold cavity prior to molding, thus reducing the flow of the material; or, delaying the placement of the core and the inserts until the mold is full but while the material is still in an uncured condition.

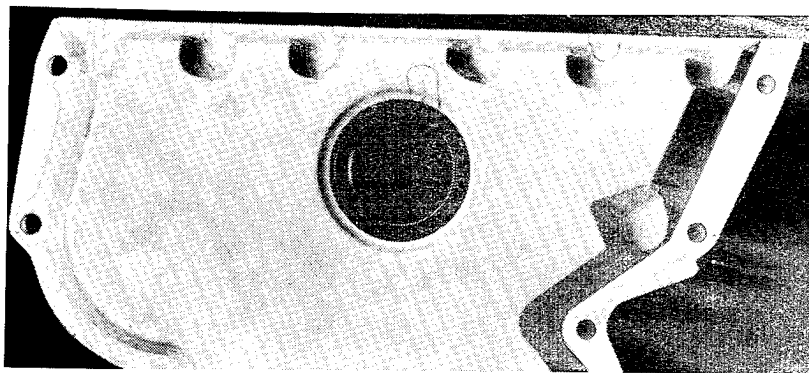
OIL SUMP BOSSES - Cracking of the oil sump bosses (Fig. 10) was generally present but not always in an identical position. Etched sections of the bosses (Fig. 11) showed a weld line across the top of the boss and fiber orientation parallel with the axis of the insert around the boss periphery. Cracking followed any line along the fiber orientation. No problem was experienced with the weld lines occurring on the top of the bosses because no adverse stress appeared to be present. The fiber orientation was obviously occurring due to the flow of the material around the insert. The close proximity of the insert to the molding tool wall caused the material, during flow, to be subjected to shear forces from the tool surface as well as from the inserts' surface. A combination of both of these shear forces did not allow any random fiber orientation in this comparatively thin section of molding. Delaying the placement of the insert until material flowed into the boss area and then forcing the insert into the still-uncured material could resolve this problem.

Fig. 10 - Front timing cover oil sump support bosses showing typical cracking

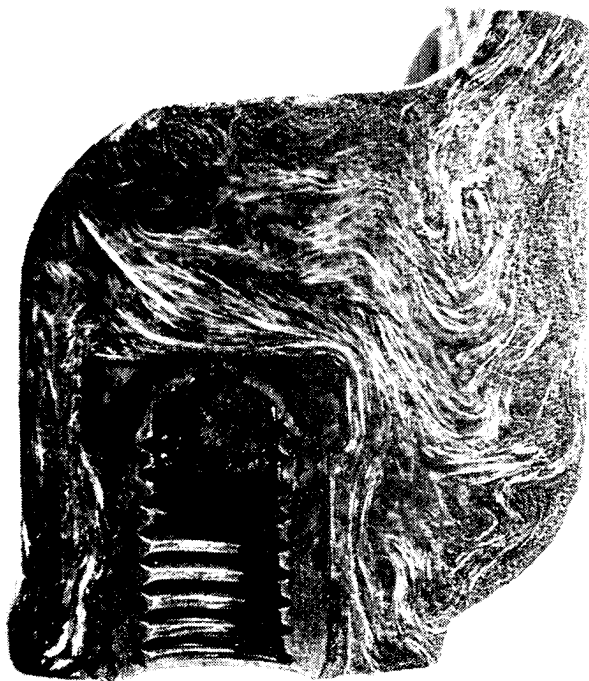
Fig. 11 - Front timing cover oil sump support boss section etched to show fiber orientation

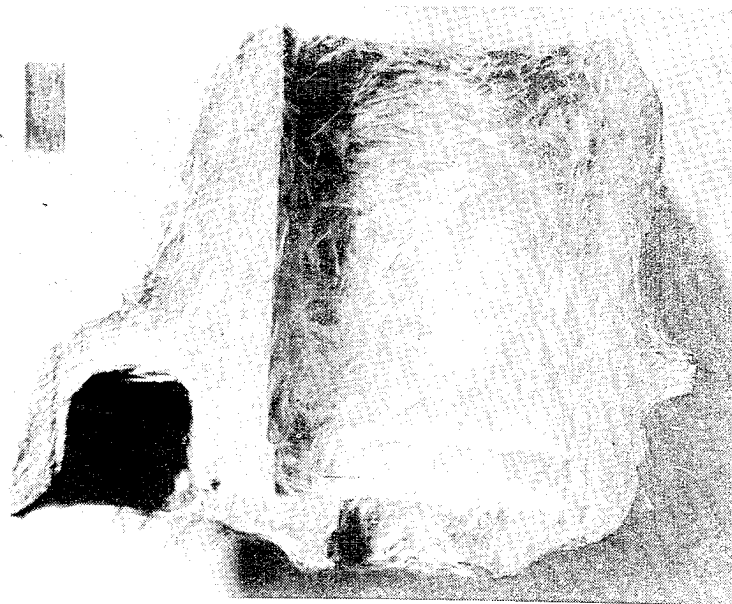
RADIATOR FAN-BEARING HOUSING - Cracking occurred in the fan-bearing housing either when pressing in the bearing or during engine test. When cracking occurred, fiber orientation was always aligned axially to the bearing (Fig. 12), which was adverse to the hoop stress operating on the fan-bearing housing.

Fig. 12 - Front timing cover fan bearing housing section etched to show fiber orientation

Random fiber orientation could be achieved by lining this section of the mold cavity with SMC material. The SMC, being randomly oriented and not required to flow any distance during molding, did not produce fiber alignment.

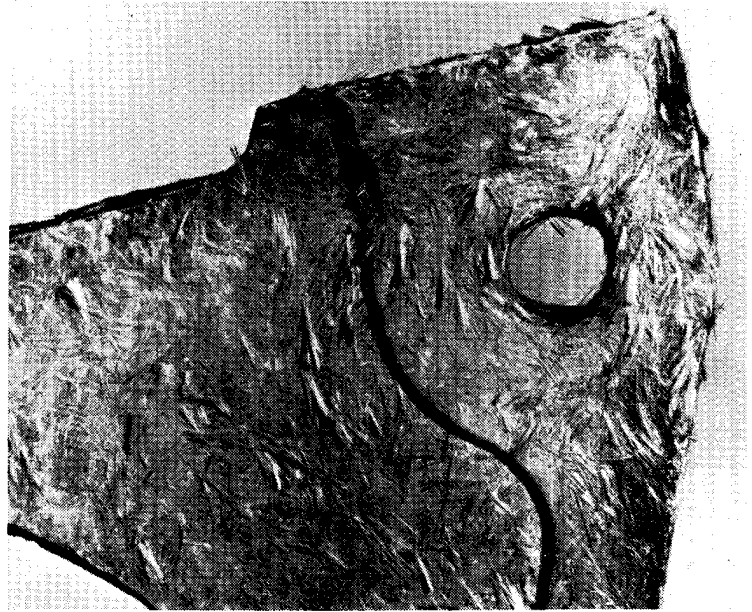
Fig. 14 - Crankshaft rear seal housing showing fiber orientation around molded-in fixing holes

although the design, at first sight could be equally good for plastic. Low-shrink DMC (15% glass, 6 mm fiber) was chosen for this component because of the need to maintain close tolerances and flatness. The DMC moldings were first tested on engine rig tests followed by vehicle trials. No functional failures were experienced with any of the moldings tested, although cracking occurred at the bolt holes and on the bosses. Etched sections, using the technique described in Appendix B, were prepared. Again, fiber orientation associated with weld lines was present around the four fixing bolt holes (Fig. 14). Cracking followed either the resin-rich area of the weld line or the fiber orientation running parallel with it.

The molding was molded without bolt holes present, the holes being jig-bored later as a secondary operation. While this obviated the orientation problem, it also invoked a cost penalty. Closer inspection showed that this problem could be rati-

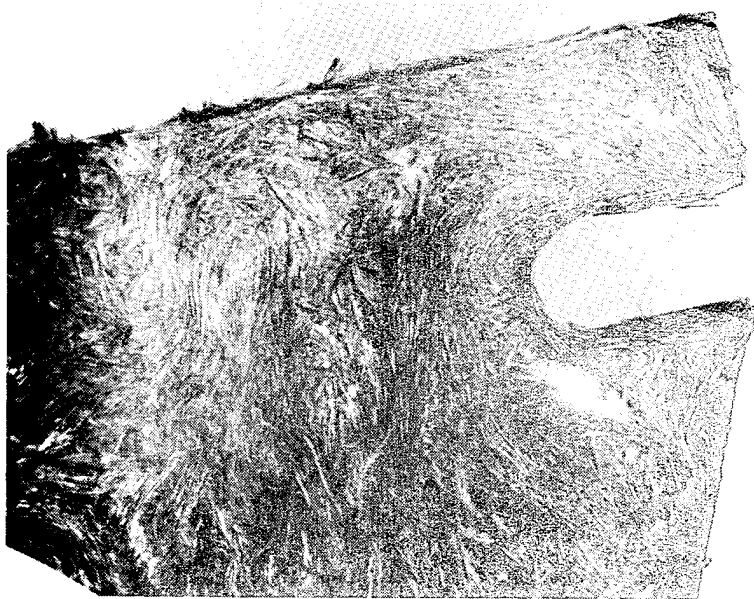
Fig. 15 - Crankshaft rear seal housing showing fiber orientation around molded-in fixing slot

fied by molding in slots instead of holes (Fig. 15). No adverse orientation was experienced with this technique, while the gasket seal face was still maintained, all at no additional component cost.
